Title: DS Vision Receiver Long / Video Tuning unit compatibility

No: 200711-02

Summary: Firmware for improved compatibility between Receiver Long and Video Tuning Unit.

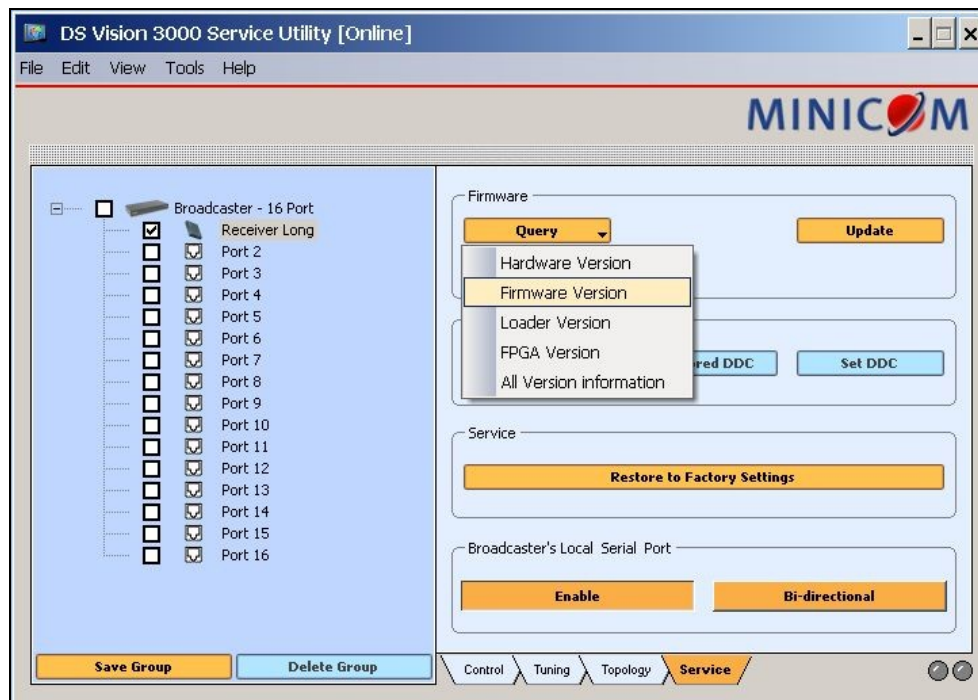
Figure 1 Service window

Click the Service tab, the service window appears:

1. Select the unit that needs to be upgraded.
2. Click on **Query** Button. Select firmware version.
3. Unit's firmware version will appear in version line.
4. To update the device click the **Update** button.
5. Browse and locate the firmware file.

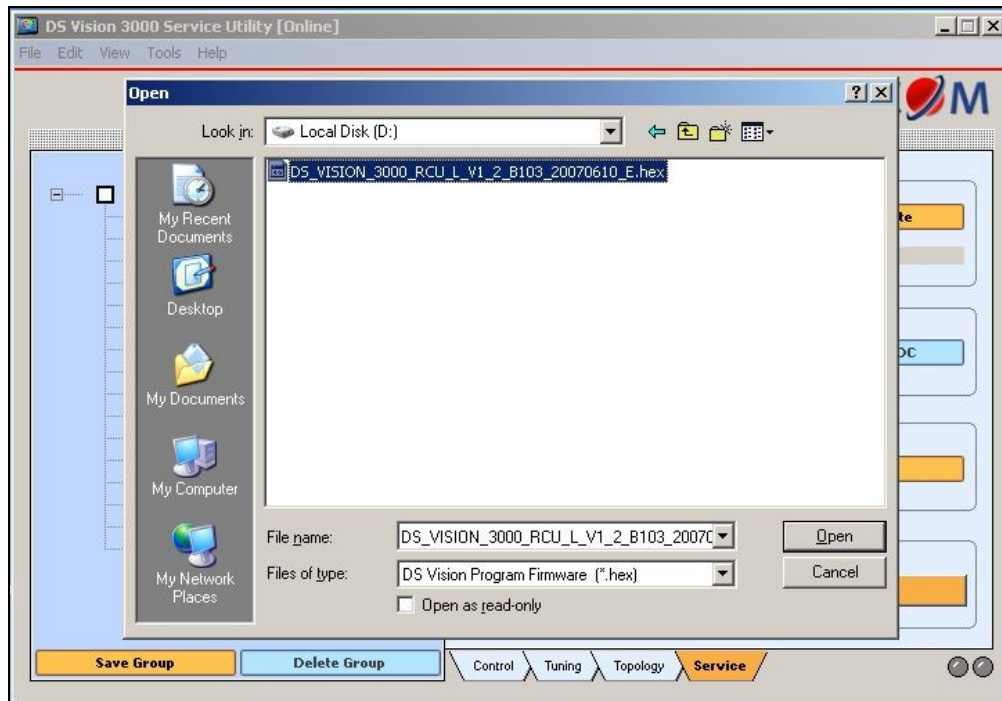
Figure 2 Update window

6. The upgrade will start immediately after opening the file.
